# PSU Green Building Internship Final Report, 2019: Karl Miller Center Post-Occupancy Study

# Karl Miller Center Post-Occupancy Study

PSU Capital Projects and Construction - Green Building Internship

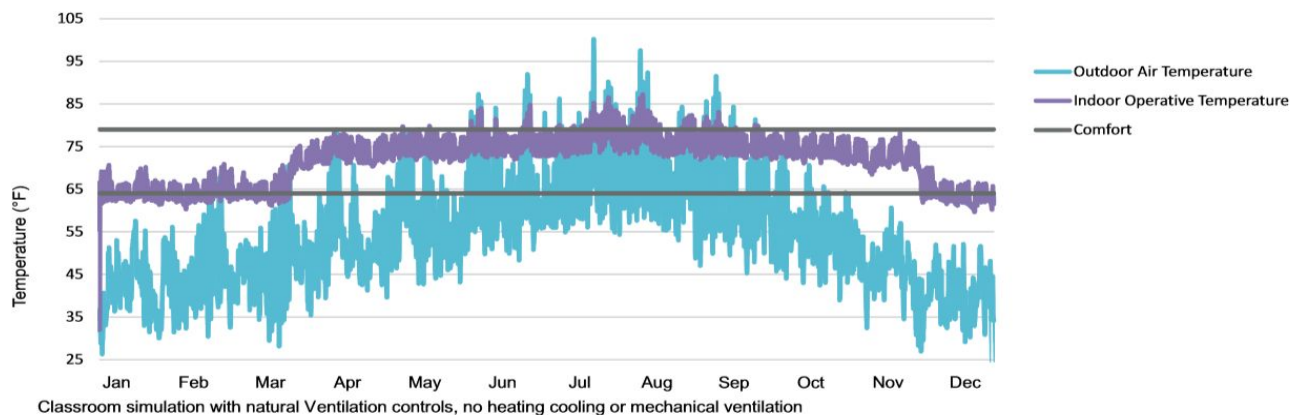
*Figure 1. 2015 Behnisch Architekten Pre-Design Natural Ventilation Simulation*

The comfort bands of interest, calculated by the design team, are situated at 64°F and 78°F. It can be discerned from the figure that the KMC rooms would frequently have indoor air temperatures in excess of 80°F throughout the summer. This was deemed to be uncomfortable, and unfortunately the design report mistakenly states that there are not any summer classes held in the Pavilion classrooms. Also in this report is an aside that shows the upper comfort limit increasing as overhead air circulation is increased. To expand on this claim, a scale was developed in which the upper comfort limit would be raised proportionally with the increased air circulation provided from local ceiling fans installed in each classroom.

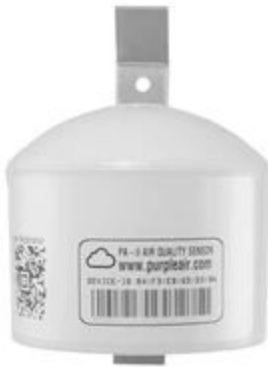
### **Purple Air Particulate Concentration Sensor**

Metrics: PM 0.5, 1.0, 2.5, 10

Intervals: 80 seconds.

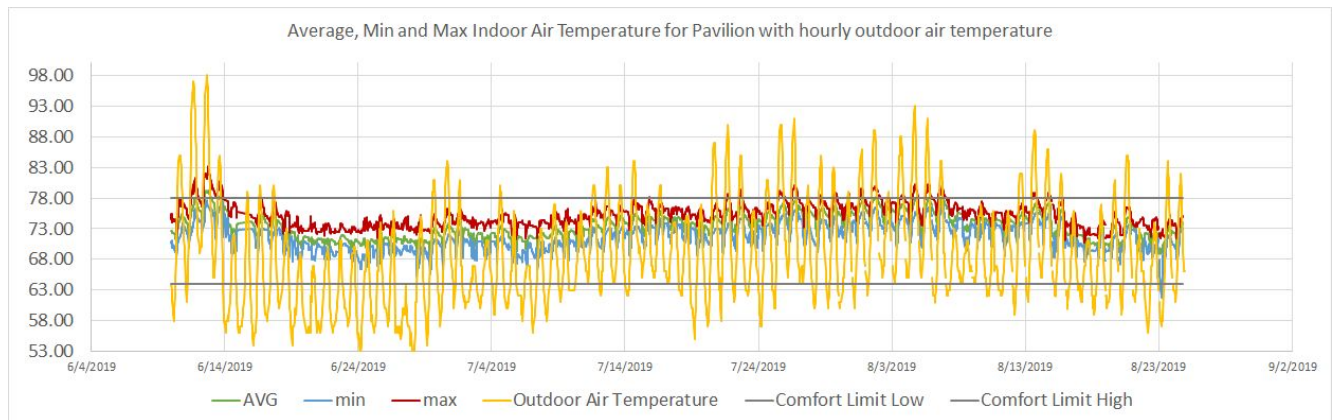
Figure 3. Summer 2019 KMC Indoor Pavilion Classroom Air Temperatures and NWS Outdoor Dry Bulb Temperature

In the above figure, the comfort bands at 64 and 78°F have been transferred from the pre-design study. For only 16 days during the summer of 2019 did at least one classroom exist that exceeded the upper band of 79°F. This was often classroom 390, but in rare cases included other rooms as well.

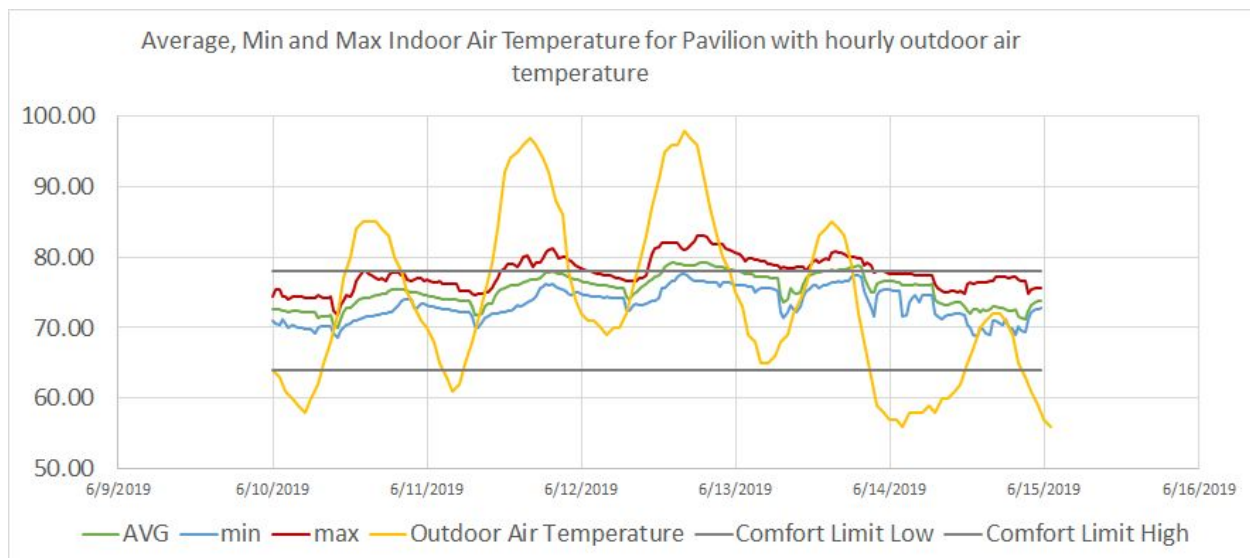
Figure 4. Summer 2019 KMC Indoor Pavilion and Outdoor Dry Bulb Temperatures: 6/10/2019-6/15/2019

The most notable time period was June 10th-14th, coinciding with final exams for spring term 2019. The high temperature for a Pavilion classroom during this time frequently exceeded the comfort band. These high outdoor air temperatures are often typical in a Portland summer

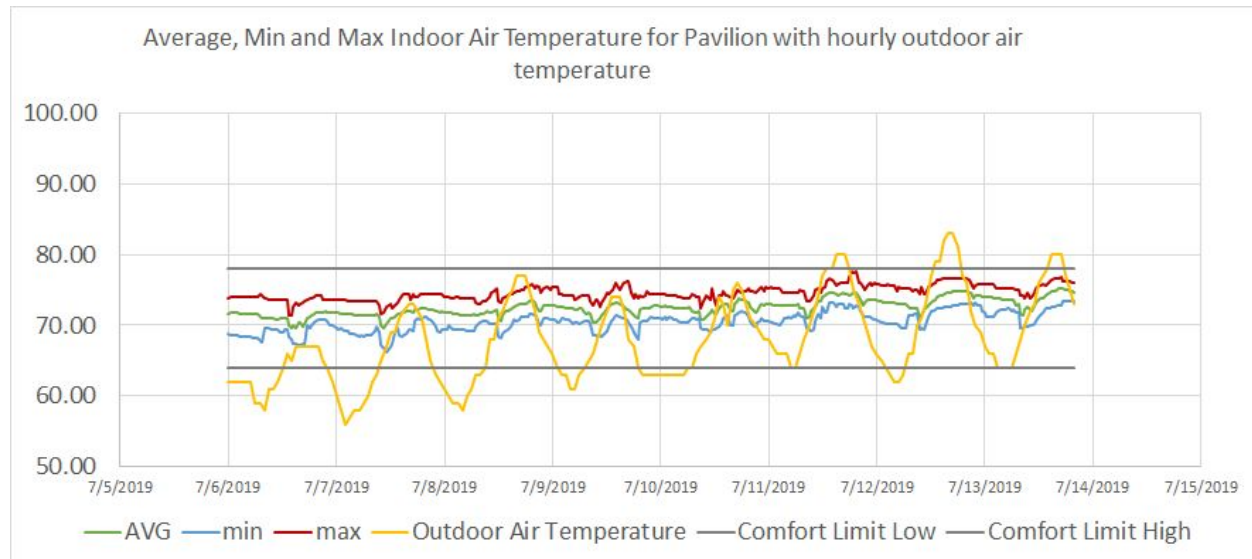
Figure 5. Summer 2019 KMC Indoor Pavilion and Outdoor Dry Bulb Temperatures: 7/6//2019-7/14//2019

The week of 7/6/2019 to 7/14/2019 represents a variety of temperature ranges that were often replicated during the research period. At these outdoor temperatures, the indoor temperature of Pavilion classrooms stays within the prescribed comfort bands. Only when outdoor temperatures exceed 88°F do the Pavilion classrooms begin to drift out of the ideal comfort zone.

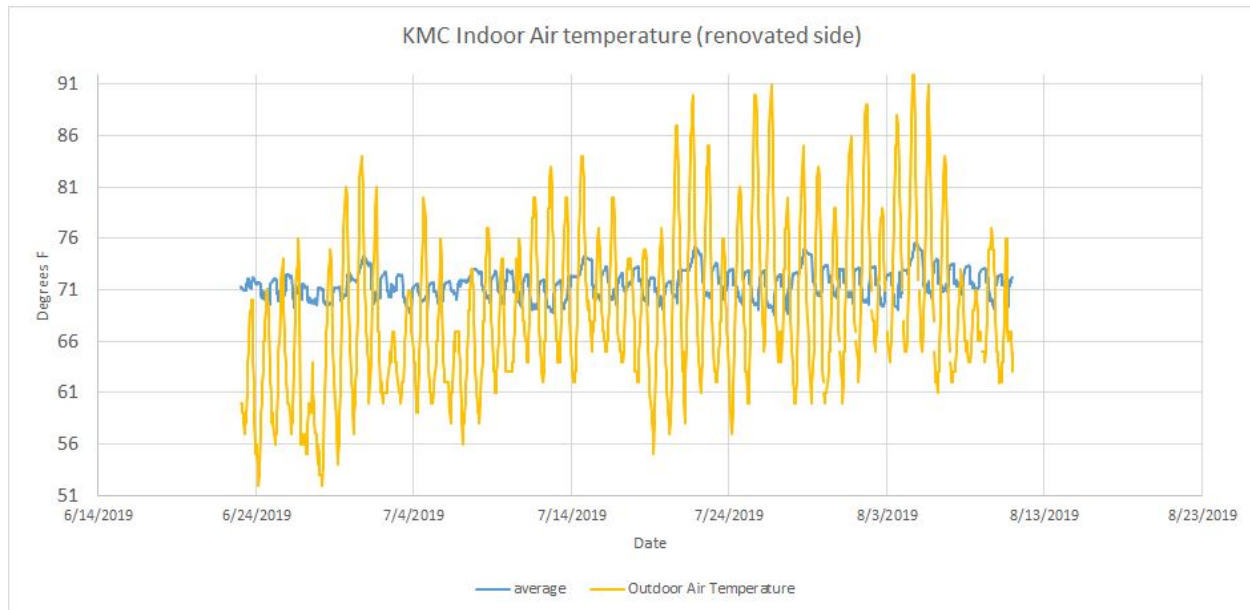
Figure 6. Summer 2019 KMC Renovated Classrooms Average Air Temperature and NWS Outdoor Dry Bulb Temperature

To compare, the average temperature on the renovated portion of the KMC consistently stays within the set points, as it is mechanically cooled.

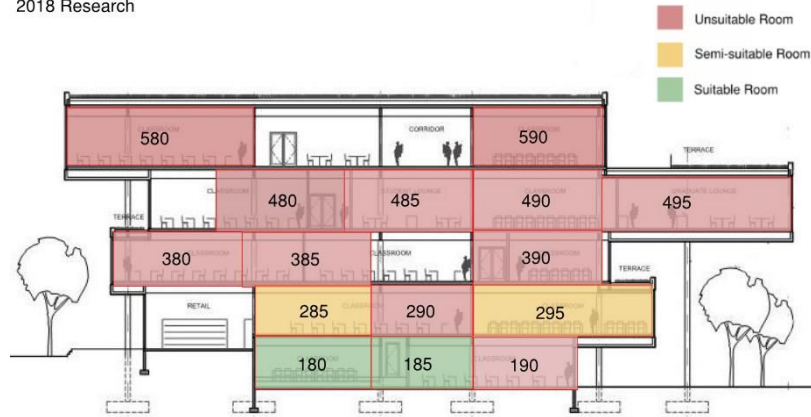
Figure 13. Summer 2018 Classroom Suitability Diagram

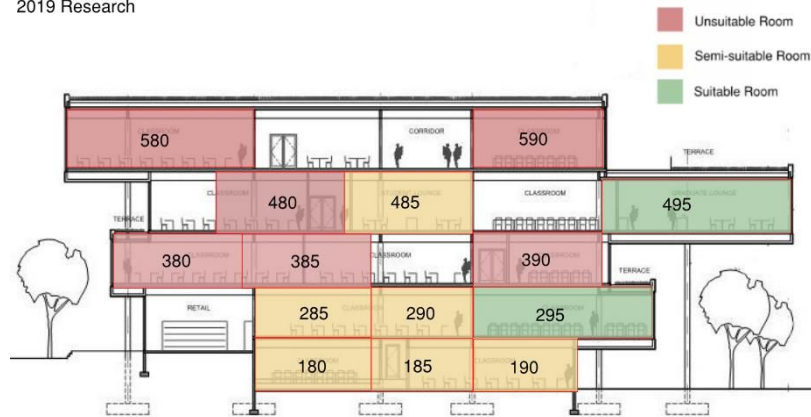
Figure 14. Summer 2019 Classroom Suitability Diagram

Once again, the elevation differences are not as drastic in the 2019 study as in the 2018 study. From the sidecut diagram it is easy to see the uniqueness of rooms 295 and 495. The exposure and cantilevered nature may play a role in their effective cooling properties. This could be an opportunity for further study in the future. Another notable change is the addition of 485 as a semi-suitable classroom. This may be tainted by 485 only hosting one class during summer 2019 term and the related absence of additional heating from occupants.

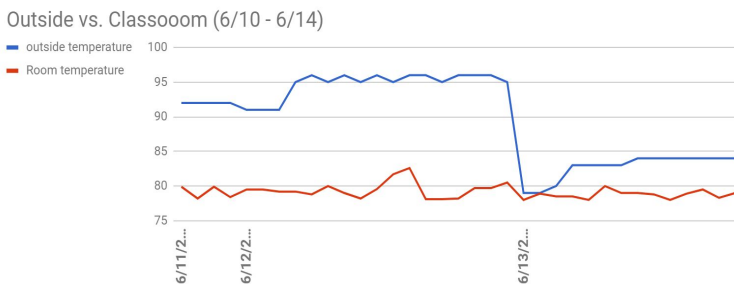
Figure 15. Comparison of indoor vs. outdoor temperatures from June 11th to June 14th.

Initiation of investigating night purge effectiveness launched based on the facts that the window operation sometimes detected as a malfunction. As the passive cooling strategies on Pavilion supposed to control with precision of the window system, investigating the current night purge operation setting was inevitable. Normally, with the night purge ventilation technique, opening windows has to incorporate with a pre-set of time during the night in order to achieve effective cooling<sup>3</sup>. Throughout having a meeting with the Mechanical team of Facility and Property Management, the current system has a lack of sequence of operations for the extreme weather. Moreover, the highest temperature drop was observed a maximum of 3°F during this summer.

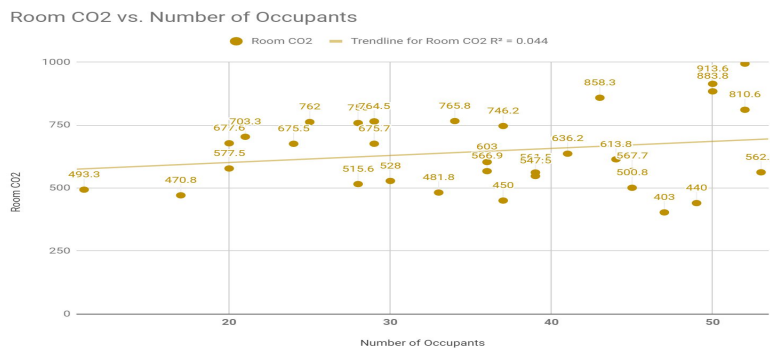
Figure 16. A linear graph of CO2 levels depend on the number of occupants from June 11th to June 14th.

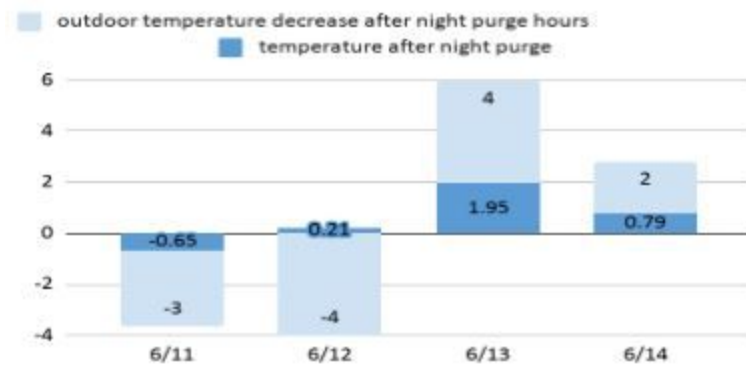
Figure 18. Night purge effectiveness related to outdoor temperature

Currently, Siemens Insight employed to control the window operation, and the night purge operation is occurred by detection of temperature difference, not set by time. In the final week, we collected the temperature and CO2 levels from BAS and analyzed temperature changing after windows open for night purge with the current setting. The current setting for night purge is opening windows when classroom temperature reached 72°F. In addition to the last year research of Omar and Jocelyn, the night purge effectiveness with the thermal mass of the concrete slab was observed as the average of 0.94°F.

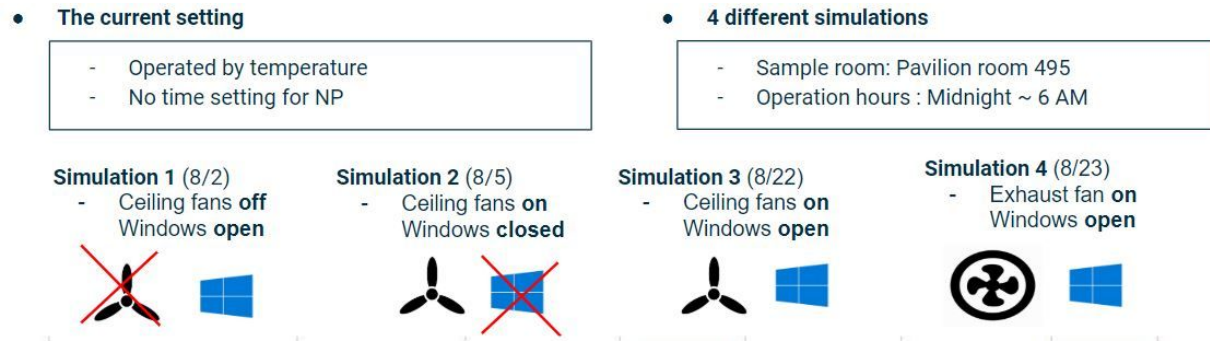
Figure 19. Simulation with 4 different sequences

Simulation for evaluating the night purge effectiveness on releasing heats and CO2 levels is done by planning 4 different sequences of operations with utilizing the sources. The sources that utilized for this simulation were selected based on the criteria which meet the low energy use performance and no extra adding on the facility. In the design stage, Jason Luce, Mechanical engineer in FPM cooperated to build the 4 different sequences.

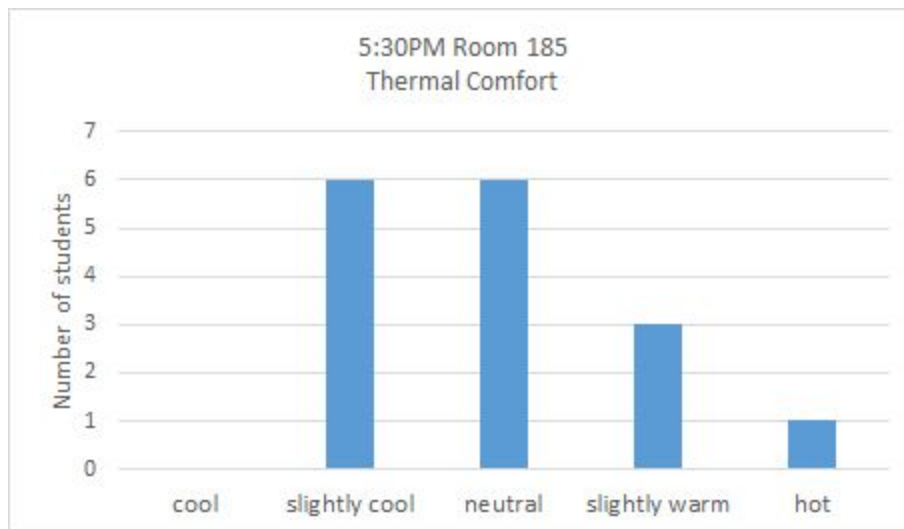
*Figure 21. Survey 2: Room 185, Thermal Comfort Responses at 5:30pm. Outdoor Temperature: 80°F, Indoor Temperature: 75°F*

The outdoor temperature during this evening class was 80°F. Oddly, a large number of students felt slightly cool in the classroom. This can be compared with a morning class with only a two-degree indoor temperature increase, as it was 77°F in the morning class and 75°F in the evening class.

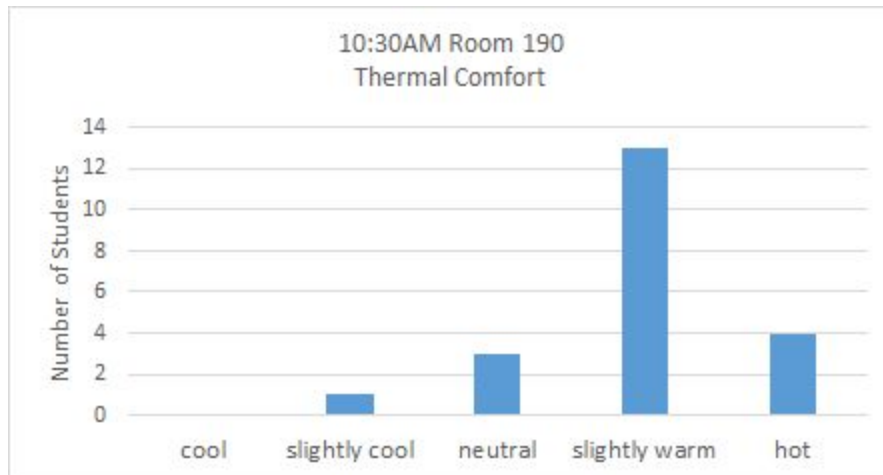
Figure 22. Survey 5: Room 190, Thermal Comfort Responses at 10:30AM. Outdoor Temperature: 77°F, Indoor Temperature: 77°F

Nearly all students in this class reported feeling slightly warm. Upon entering the classroom, the researchers noticed the windows were closed and the ceiling fans were not turned on. With the windows open and ceiling fans operating, the interior comfort level increased, not just as noted by the researchers, but also verbally from students in the class.

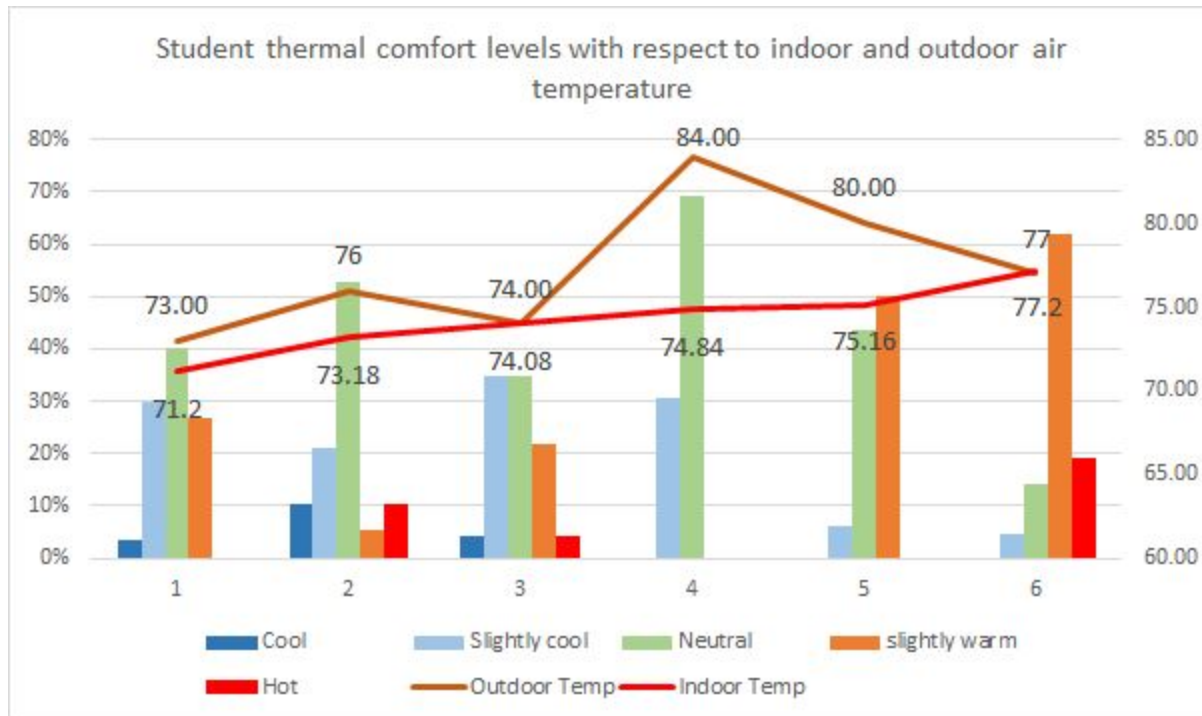
Figure 23. Aggregate survey responses versus indoor and outdoor air temperature at the time of survey distributions

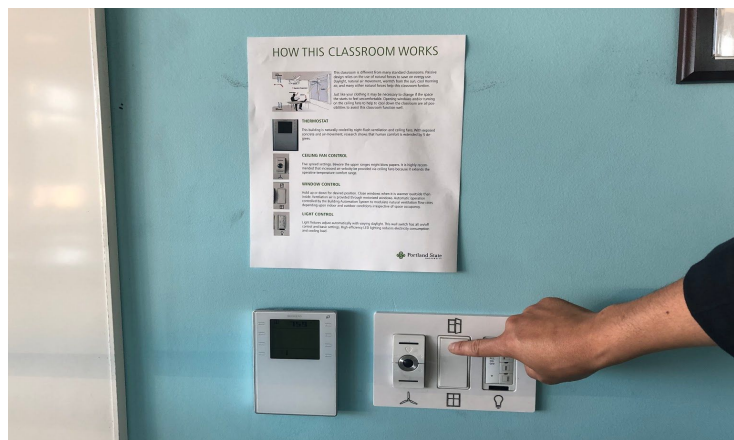
Figure 25. In-class control system during window opening
